Alaska Aviation System Plan

Kotzebue Airport

Chapter 6

Western Alaska Airport Resiliency Study

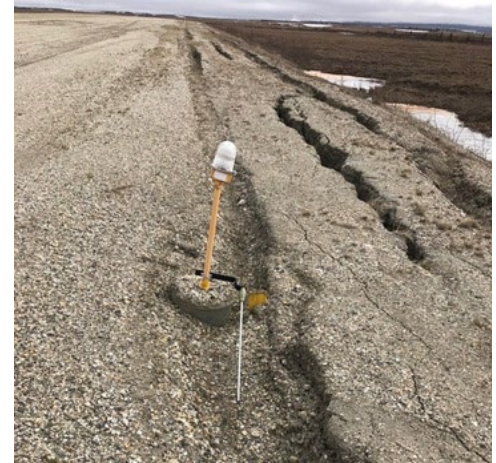
Permafrost is a layer of subsurface soil that remains frozen year-round and is insulated by the soils and structures above it. The thickness and composition of the insulating material changes the insulating effects; for example, an embankment provides more insulation at the shoulder (full thickness) than at the toe (thinnest layer). This results in an uneven thawing of the permafrost, which creates differential settlement between the embankment shoulder and side slopes. This behavior is often referred to as shoulder rolling, where the differential settlement causes the shoulder to separate and roll away from the embankment. Key visual cues of this behavior are surface cracks parallel to the runway centerline,

Figure 4. Shoulder Rolling Interfering With the Lighting System at Noorvik Airport (D76) [DOT&PF, 2019].

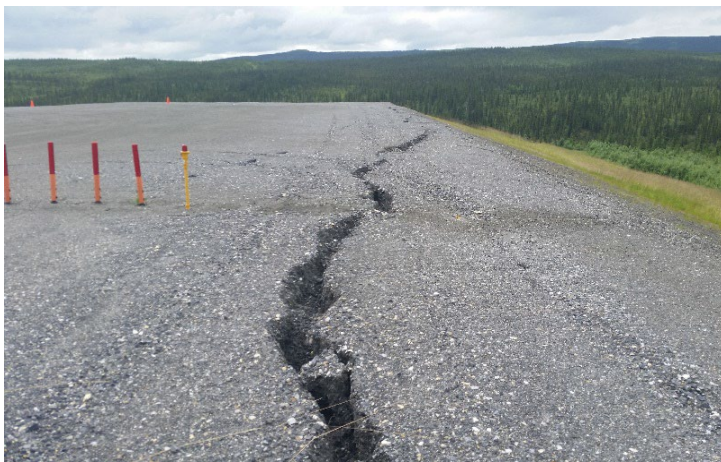
The ideal placement for an airport is relatively flat ground, with uniform subgrade; however, not all communities in Alaska are in areas of level and obstruction-free terrain, optimal for the siting of a runway. More often it is irregular and hilly terrain requiring varying embankment thicknesses, often resulting in differential settlement from thicker embankments inducing heavier weight on subsurface soils. Another common condition is rolling terrain, which often includes drainages and wetlands that require extra consideration. Ultimately, this varying terrain increases the likelihood of differential settlement because subgrade materials compress differently when loaded with embankment materials, which can lead to surface cracking, as shown in Figure 6.

Figure 6. Longitudinal Cracking at Kiana Airport (IAN) [DOT&PF, 2023].

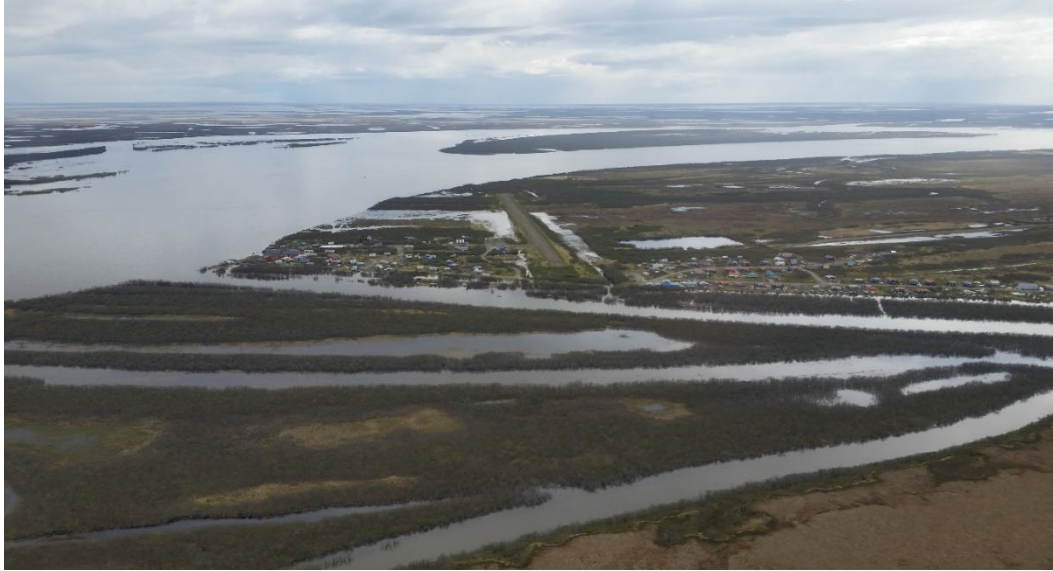
Figure 8. Flooding Along Rivers is a Common Threat to Communities and Airports; (Photograph of Napakiak Airport [WNA] taken by DOT&PF on June 6, 2023).

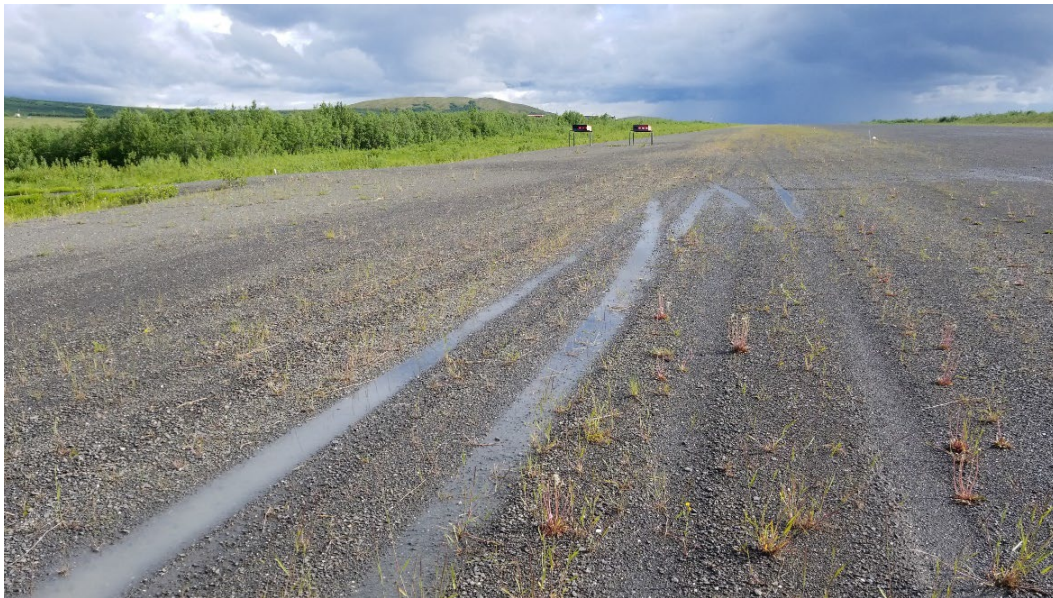
Changes in precipitation patterns also impact embankment integrity. More frequent precipitation and more severe storms can increase the rate at which fines are washed out of the embankment, and locations that receive more winter precipitation may experience less ground freezing because of the insulation of accumulated snow. Increased precipitation can also create soft runway surfaces, which can lead to ruts, as shown in Figure 9.

Figure 9. Rutting of the Runway Surface at St. Mary's (KSM) (Photograph taken by DOT&PF, 2021).

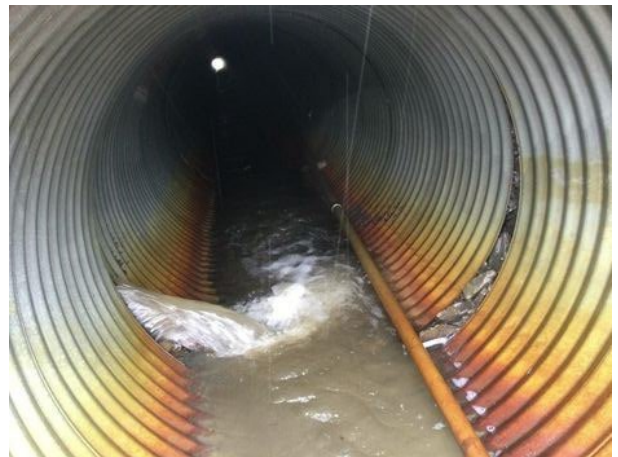
- ▶ **Installing culverts under runways.** An additional construction consideration is the installation of culverts within the embankment (under a runway). A common issue observed on runways is differential settlement of the embankment on either side of the culvert. As a general design principle, the materials under culverts are over-excavated and backfilled with material that provides a solid foundation, and bedding is placed around the culvert. This is accomplished because heave or settlement under a culvert can cause its failure, which can be catastrophic in comparison to minor surface cracks or shoulder sloughing. Ultimately, because culvert sections are built to be more durable than the adjacent embankments that naturally compress and settle or may heave, a bump on the surface often occurs.

Figure 10. Takotna (TCT) Runway Cross Culvert Failure Caused by Differential Settlement.

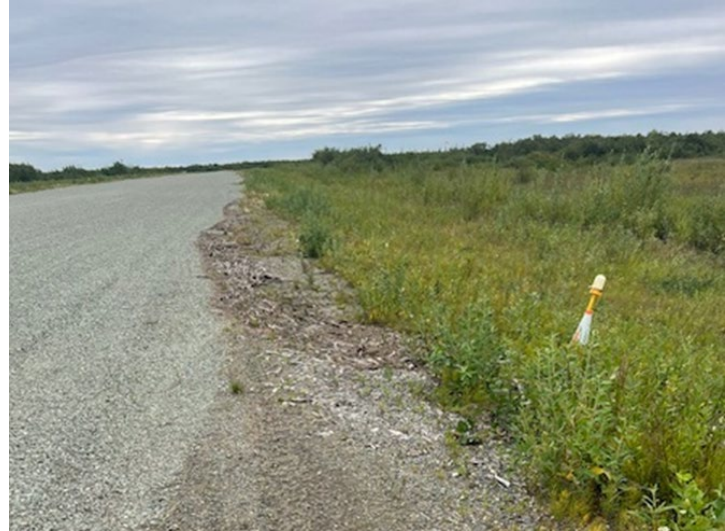
Figure 11. Debris Inside the Light Line of the Runway at PKA.

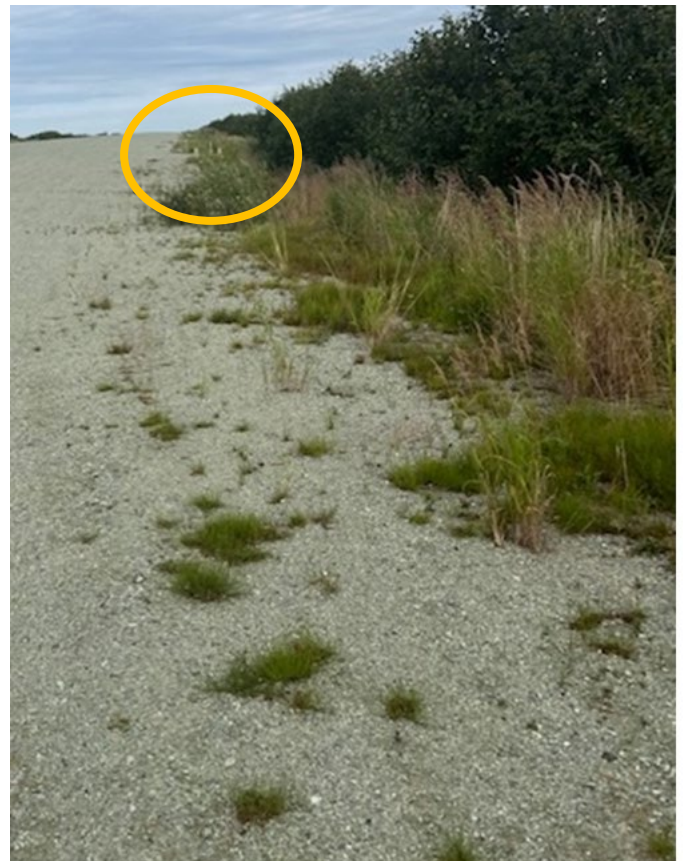
Figure 15. Encroaching Vegetation is Obscuring Edge Lights at Tuntutuliak (A61). The yellow oval photograph indicates the location of the lights.
