Alaska Aviation System Plan

Kotzebue Airport

Chapter 6

Western Alaska Airport Resiliency Study

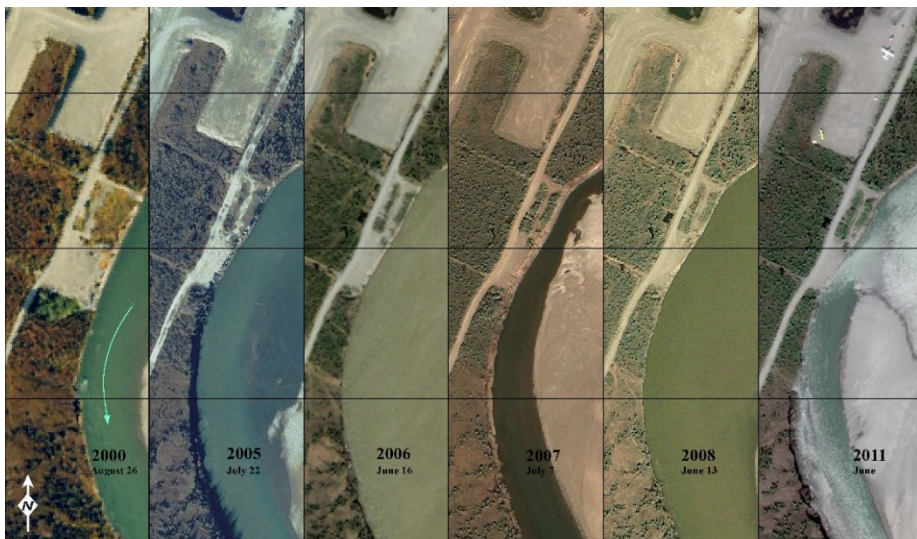
This process is more common in portions of a waterbody where the flow of water is faster, such as the outer bank of a river curve. Over time, this slow removal of material from a soil face can result in major topography changes and widening or redirection of waterbodies. This process is illustrated in Figure 7.

Figure 7. Noatak Riverbank Erosion, 2000–2011 [DOT&PF, 2013].

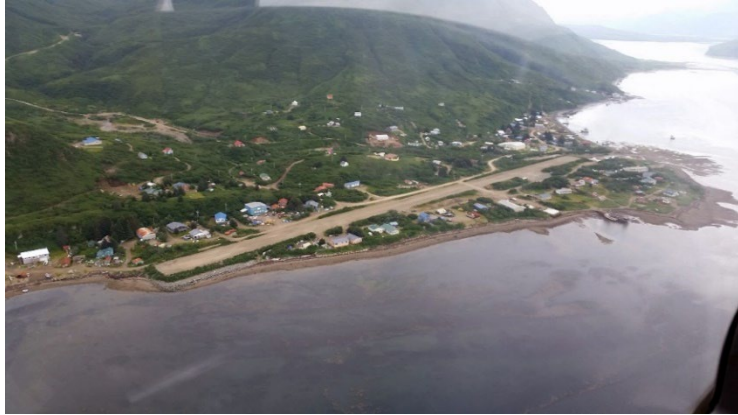
The runway surface sometimes becomes very soft in spring and during periods of heavy precipitation and has experienced flooding from storm surge. The runway is reported to be performing well.

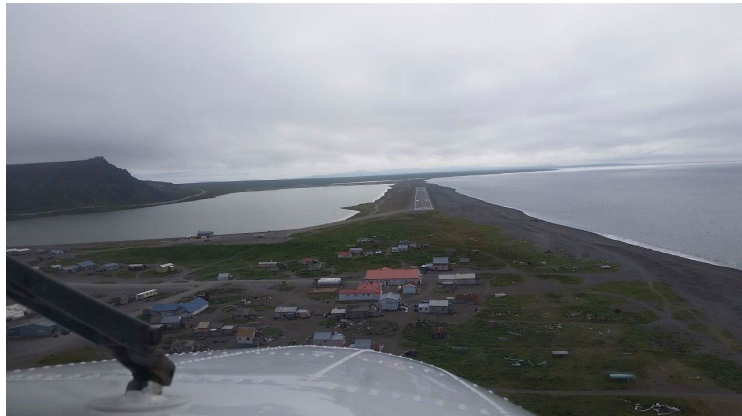
Limited documents are readily available to aid in identifying issues at the airport, but general deterioration of the runway has likely occurred. The last pavement rehabilitation grant was issued in 2017, and the current pavement condition is listed as fair. PCI reports between 2002 and 2014 were in the 40–46 range (Rehabilitation). Before 2017, the last reported paving project was in 1985 (per the 2008 *Gambell Airport Pavement Inspection Report* [Horn, 2008]). The runway is performing poorly.

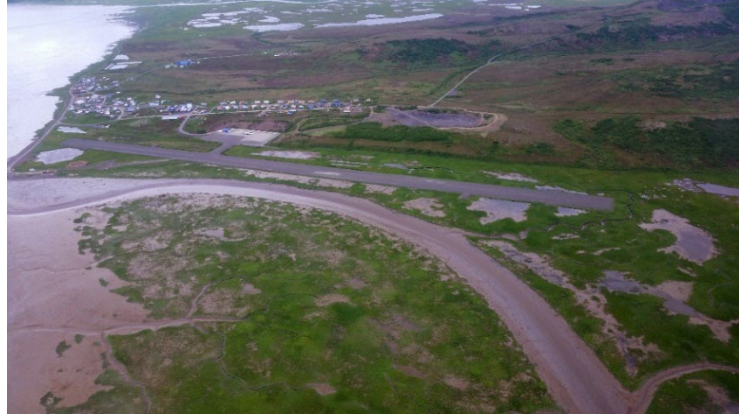
The airport was constructed in 1975, with significant improvements made in 2011. The on-site material source provided good quality construction materials, and organics were not left in place during construction. Overall, the runway is performing well and does not experience any significant issues.

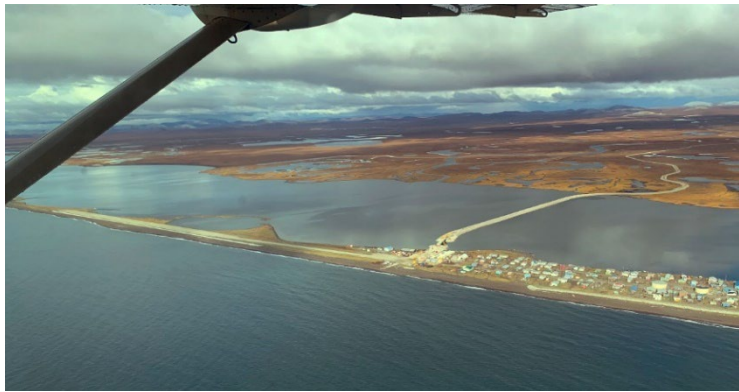
Materials used in airport construction consist of fine to coarse sands and gravels with overlain silt. The airport is becoming increasingly susceptible to severe storms, resulting in slope erosion at the airport and the potential for storm debris to impact the runway. The airport relocated once before from the north end of the lagoon to its current site. The community has long considered relocation from its current site to a more protected area approximately 12 miles inland. Safety and long-term viability concerns are causing DOT&PF to explore potential solutions, including the relocation to a more protected area. In 2018, an evacuation road was constructed across the lagoon to provide residents with an egress route in case of severe storms. The road leads to a new school site that is inland and protected from the coast. The runway is performing poorly.

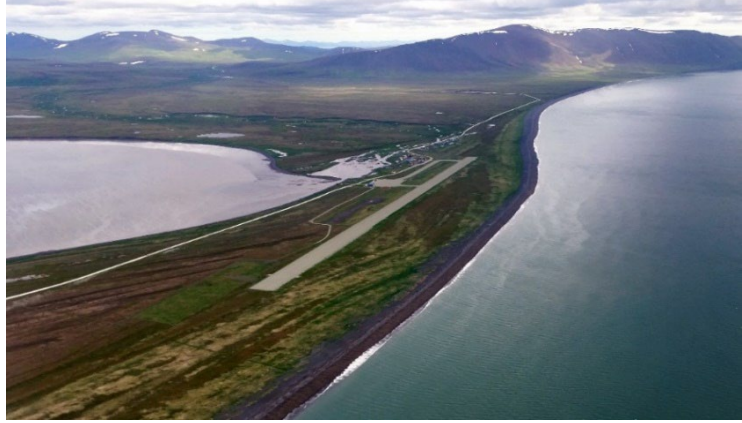
Construction materials included glacial till or still water deposits consisting of silty gravel and sand. The runway was relocated in 2012 and is generally performing well, with no major issues.

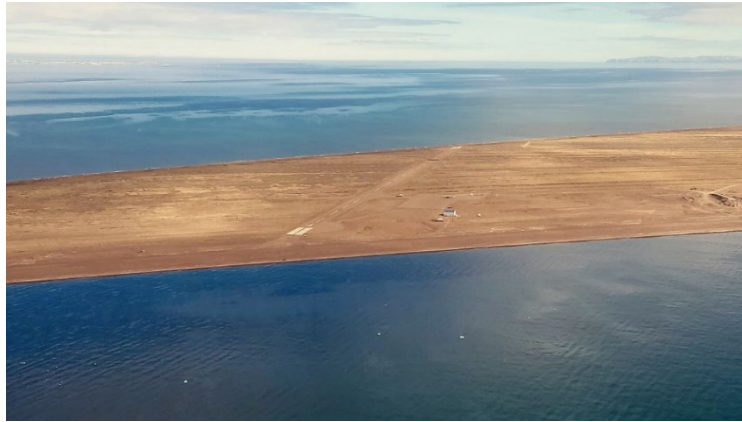
Construction materials included gravelly sand with low fine contents. The runway stability can be attributed to non-frost-susceptible sandy gravel material and, although permafrost was encountered at a depth of 11 feet back in 1973, no ice was visible. The RSA is facing erosion issues, and the runway and apron have very poor pavement conditions. The airport has experienced flooding in the past. A project to realign the runway was completed in 2024, improving the reported runway conditions.

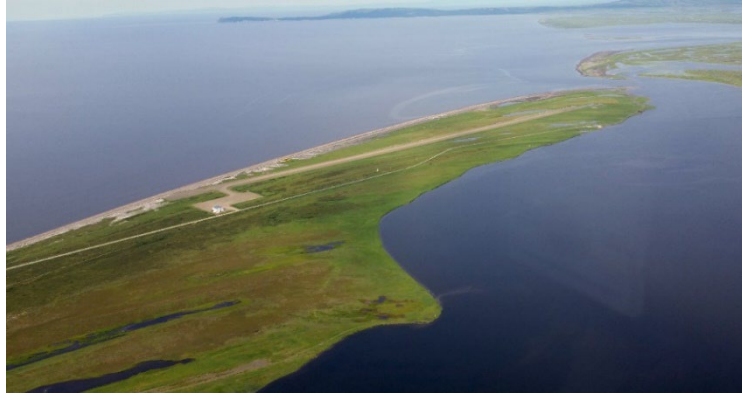
Construction materials included sand, gravelly sand, and sandy gravel, and culverts exist within the runway embankment. The runway becomes soft in the spring and during periods of heavy precipitation. It has experienced flooding in the past, notably in 2005, which led to a Federal Emergency Management Agency (FEMA)-funded project in 2008. The runway is performing poorly.

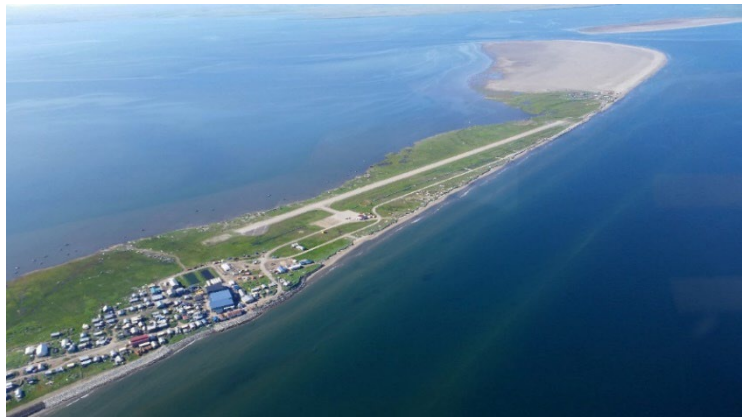
The runway, taxiway, and apron were rehabilitated in 2015, which included asphalt paving and a new lighting system. A seal coat on the pavement was applied in 2022. In 2023, a project for rock revetment along the airport access road was completed. Also in 2023, a winter storm caused a substantial amount of ice (about 30 feet tall) to be pushed over the rock revetment onto the road. As of 2024, further rock revetment work is in progress along the road, outside the airport property, which leads to the landfill. The runway is threatened by coastal erosion and is performing poorly.

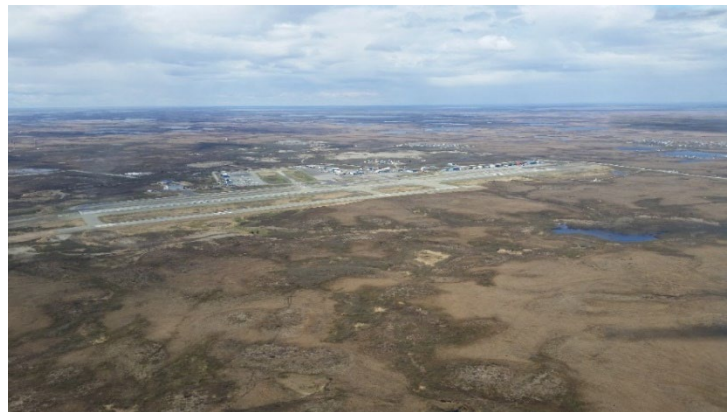
Organics were removed before runway construction and culverts exist within the embankment. Based on interviews with state aviation managers and data review, Runway 12/30 is performing well. The good condition of the airport is likely based on the removal of organics, consolidation of the native materials, and placement of sound and stable embankment materials.

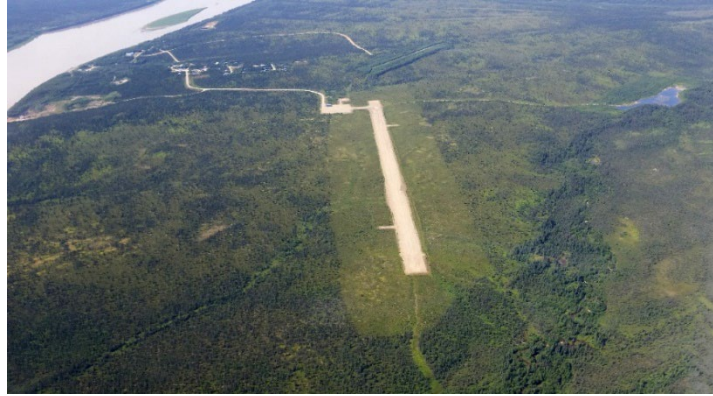
There are no culverts in the embankment. The runway has frost heaves and dips in several locations and a recurring dip at the runway/taxiway intersection experiences ponding. The taxiway/apron intersection has significant erosion, and surface cracking is occurring nearby. Shoulders along the runway are also eroding. The cause of current rutting and frost heaving is inconclusive based on available data. Design sections from the 2002 Runway Relocation project seem reasonable in material depth and proposed excavation limits. Material used for relocation was taken from adjacent material sources which is likely susceptible to frost heaving. The runway is performing poorly.

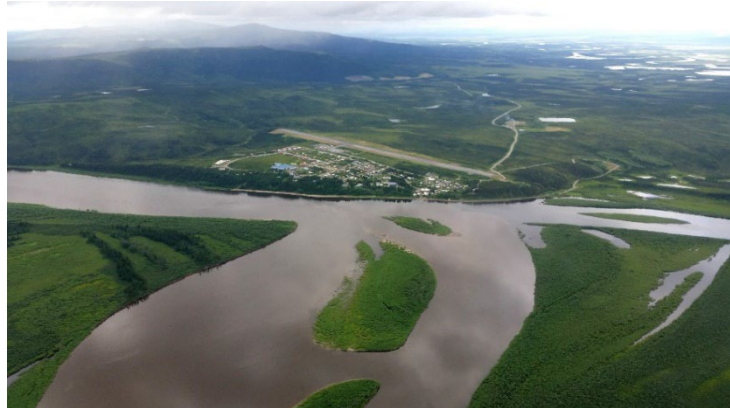
Organics were not removed before airport construction, and there are no culverts in the embankment. The runway was realigned and lengthened in 2019. The embankment material was of decent quality (for rural airports). The lower section of the new embankment was constructed with materials containing up to 50 percent silt, followed by a 5-foot granular layer and topped with subbase and base course material. A local material site located 3 miles northwest of the airport was developed for this project construction. The westernmost 1,000 feet of runway are currently experiencing settlement, which is causing cracking and sinkholes. The runway has experienced a soft surface and rutting, frost heaving and dips, and longitudinal cracking. The runway experiences ponding at the toe and is performing poorly.

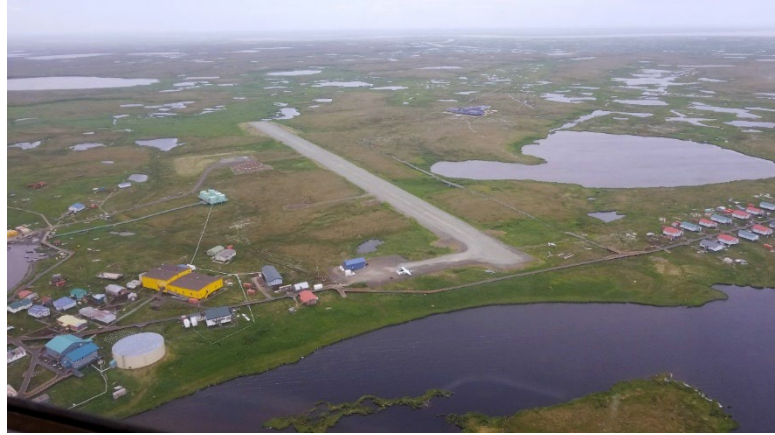
The airport is currently under construction to expand the runway to 3,300 feet long by 75 feet wide. The original construction materials consisted of silty sand with gravel. Before reconstruction, the runway surface was soft and had heaves, dips, and longitudinal cracks. Embankment slopes were also experiencing erosion and vegetation growth was noted as an issue. The runway was performing poorly.

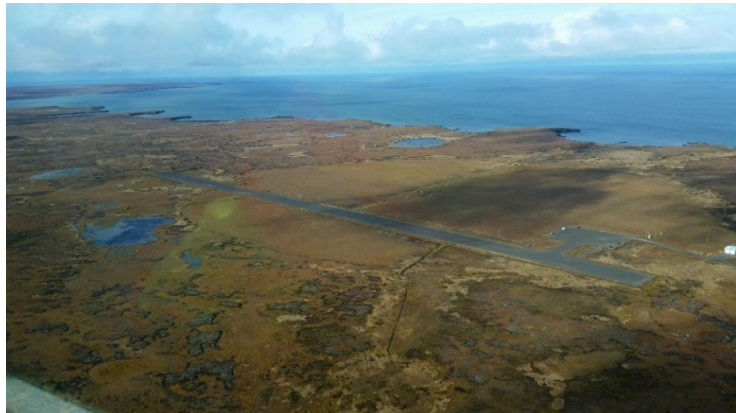
The runway has performed well for a long time, with the last major rehabilitation project occurring in 1984 with a minor preservation project in 2012. Over time the surface course material has degraded, and the embankment has started showing signs that the underlain frozen soils are thawing. A letter from the community states that the runway is sinking into the tundra [Williams, 2016]. Funds for a rehabilitation project for the airport have been obligated at the time of this study. The runway is performing poorly.

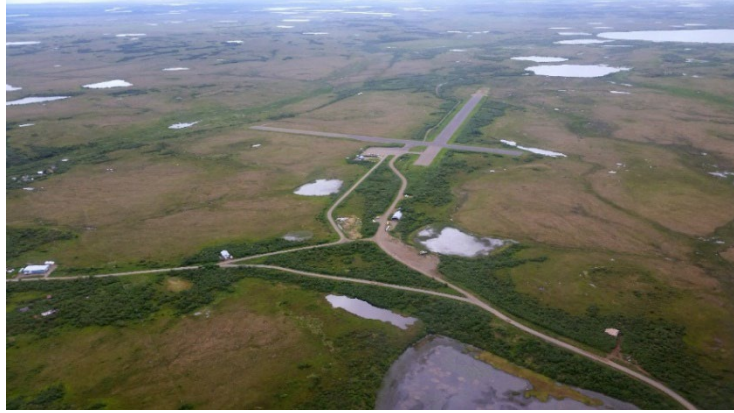
Both runways were resurfaced in 2020. Before the runway rehabilitation project, one runway (05/23) was closed, and the usable length of the other runway (13/31) was shortened because of soft surface conditions and severe rutting. The rehabilitation project did not restore the original full length of Runway 13/31. The final length was approximately 560 feet longer than the pre-rehabilitation runway. The runways are performing poorly.

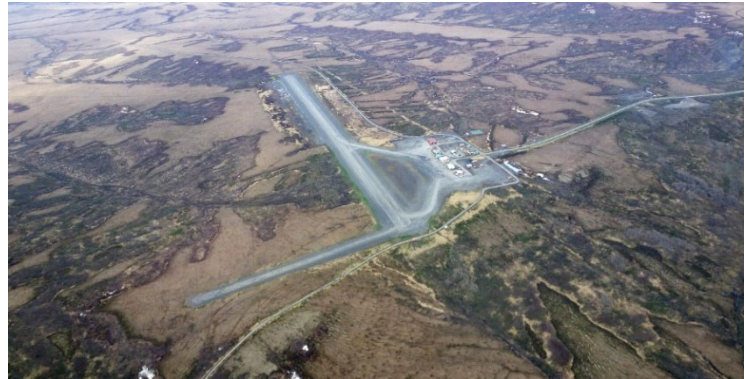
Construction materials included siltstone, shale, and sedimentary sandstone, and there are culverts in both embankments. Soft spots on the runway have been investigated and silt, a thick organic layer, visible ice, and permafrost thaw features exist below the runway fill.

An improvement project is currently under construction that will address deficiencies in FAA RSA standards, runway surface degradation, and drainage issues. Much of the construction work was performed in 2024 and will be completed in 2025. Before construction, the airport was performing poorly.

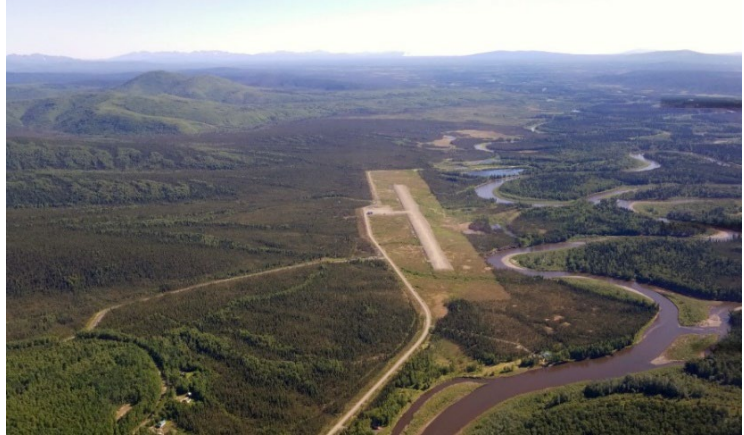
The 2020 Aviation Project Evaluation Board (APEB) nomination form notes that the culverts in the embankment are inadequate. Since being relocated in 2009, the runway has experienced settlement and drainage issues. The runway, taxiway, apron, and access road have cracks, dips, bumps, rutting, ponding, and soft spots. The runway is performing poorly.

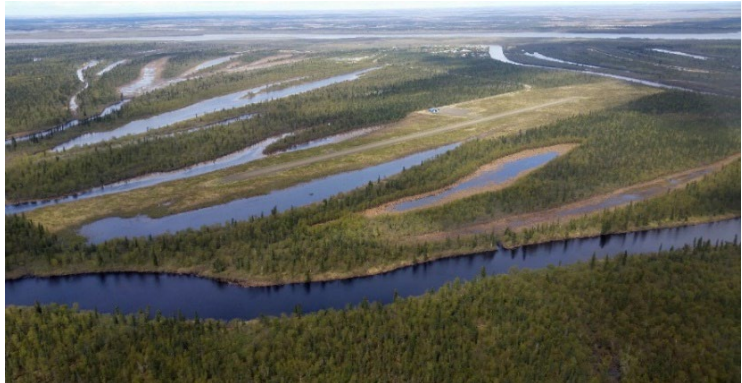
The as-built drawings indicate that organics were left in place during airport construction and there are no culverts in the embankment. Materials used in runway construction included sand from a sandbar at the confluence of the Tuluksak and Kuskokwim Rivers.

The airport was relocated in 2009 onto relatively flat ground, with the runway grade set at 0 percent. The embankment thickness is approximately 8 feet. Data to help understand the underlying issues for this airport were not readily available. The runway is performing poorly.

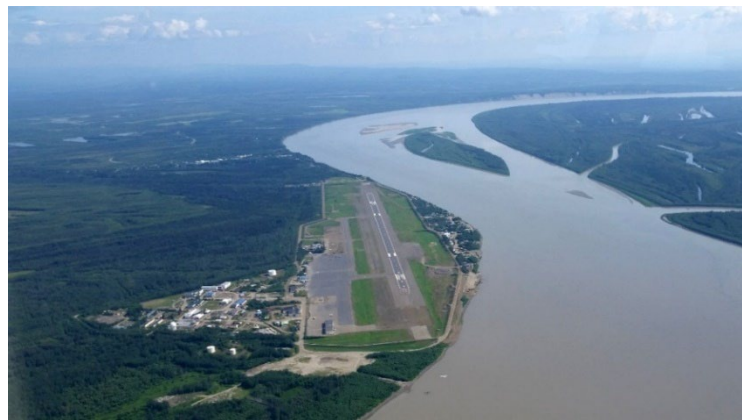
within a diked area to protect it from flooding and erosion but there is concern about the long-term stability of this dike. The surrounding terrain is floodplain, with native soils described as gray-brown micaceous silt with various amounts of sand and 30 percent visible ice in thin ice lenses. In deeper regions, the soil is gravelly sand and gravel. The pavement at the airport is generally performing well.

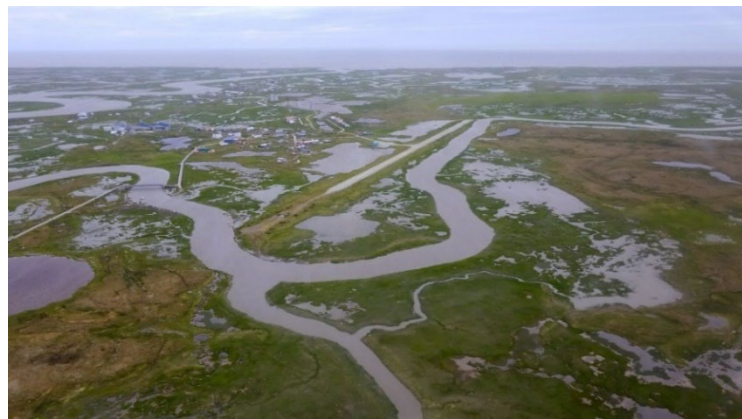
Construction materials included silty sand with gravel for the airport surface, sandy silt with sand fill (existing subgrade) and sandy silt or silt with sand. Organics were left in place during construction the original construction. Minimal drainage ditching exists, which causes the embankment materials to remain wet and soft.

The runway has numerous humps and dips, as well as extensive ponding. Ongoing embankment erosion is occurring, particularly at the south end. At 1,835 feet long, the runway is scheduled for reconstruction and lengthening pending acquisition of adjacent private property. Air carriers discontinue service to the airport regularly when runway conditions are poor. In 2018, a small amount of surface course material was imported as part of an emergency rehabilitation project. The material was used to level the runway to allow continued aircraft operations. The runway is performing poorly.

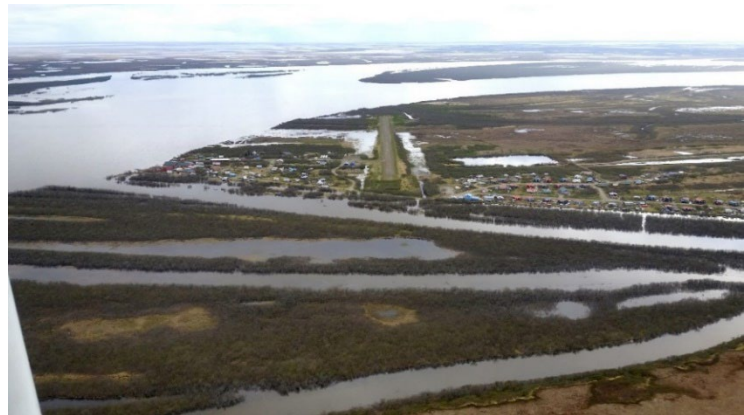
Construction materials included silty fine sands with trace organics, and there are culverts within the embankment. Vegetation growth was noted as an issue. The runway was reconstructed in 2002 and currently faces issues with soft surface conditions, potholes, and ponding. The runway is performing poorly.

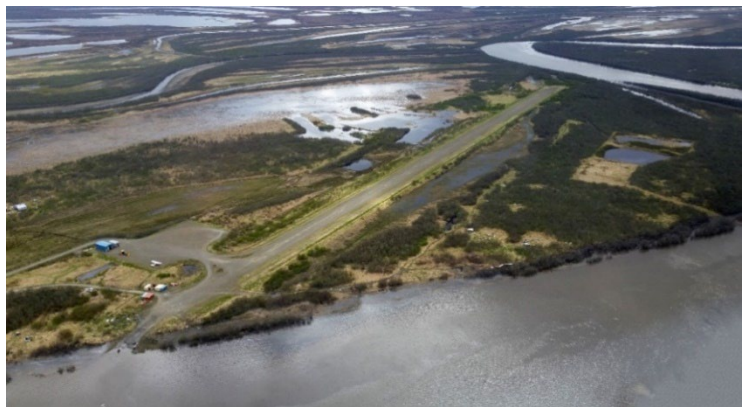
The runway has soft surface conditions, differential settlement-related heaves and dips, and is susceptible to flooding during the spring. The August 2024 site visit allowed for a quick stop at PKA. The airport surface was in good condition. A 2018 surface maintenance project had removed previously reported heaves and dips. The surface irregularities have not reappeared, indicating that minor surface maintenance projects may be an effective solution to surface issues at some airports.

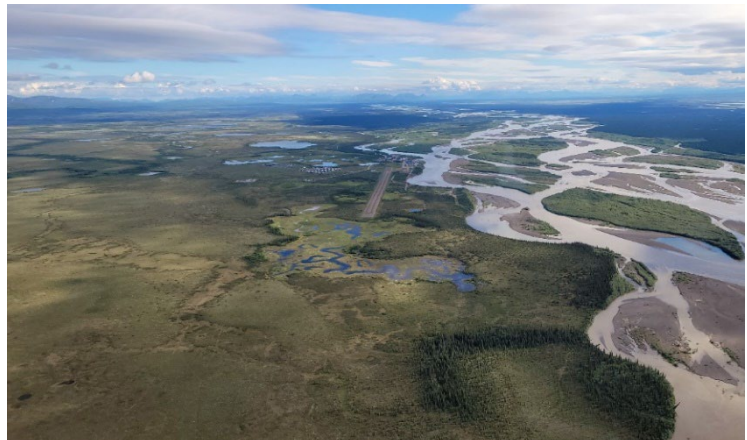
The airport's location is threatened by river erosion from the adjacent Noatak River and experiences slope erosion and flooding. DOT&PF has proposed relocating the airport. An Environmental Assessment, which had a Finding of No Significant Impacts (FONSI), was signed on September 27, 2024. The project is now moving forward with permitting, right-of-way (ROW) acquisition, and final design. The current runway is performing poorly.

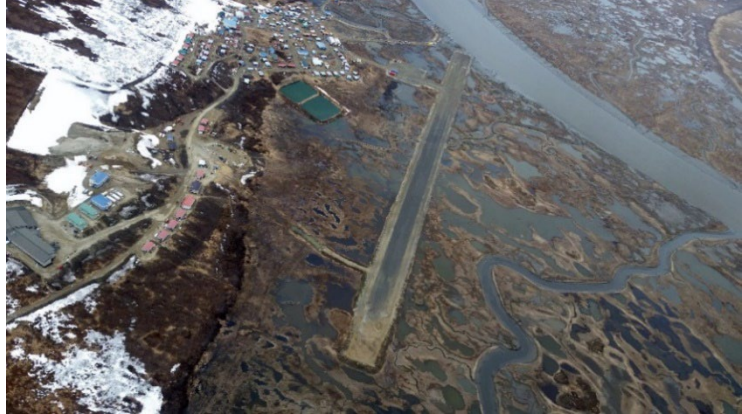
There are culverts within the embankment and ponding occurs at the runway toe. The airport is susceptible to flooding from the Kun River and experienced significant flood events in 2004 and 2013. The airport needs improvements to mitigate the risk of flood damage. Additional issues with runway conditions include surface erosion on both sides of the runway, ponding, deep ruts, and very soft conditions in spring and during periods of heavy precipitation. The runway is performing poorly.

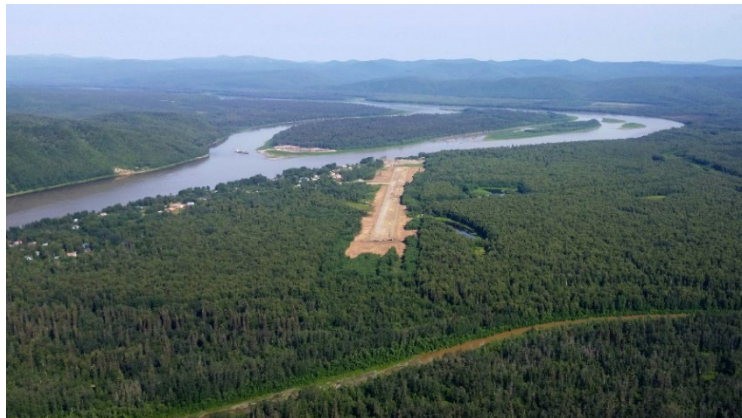
The runway underwent a reconstruction project in 1983 and a resurfacing project in 2010. The runway, apron, and access road are currently not well compacted and have soft spots and dips. A 1983 investigative report indicated long-term differential settlement should be expected where the runway was to cross an old meandering slough. A project to rehabilitate the runway, taxiway, and apron, and expand the RSAs to address these issues is scheduled for completion in September 2024. Vegetation growth was also noted as an issue at this airport. The runway is performing poorly.

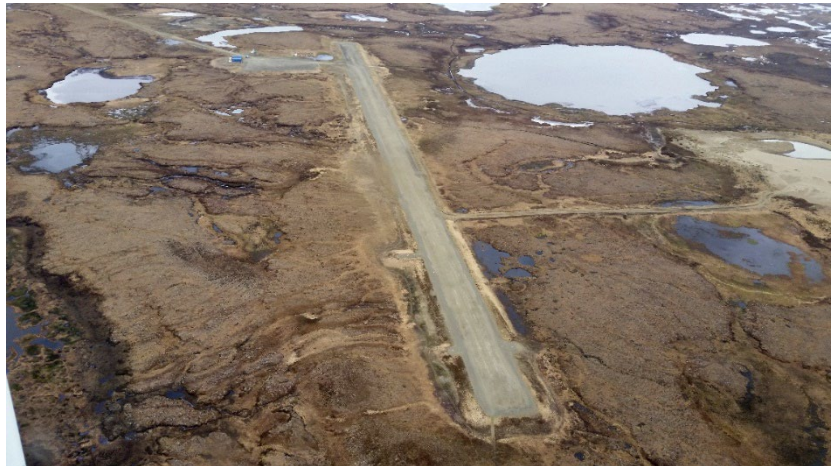
The runway has historically become soft and rutted during the spring breakup season but is now experiencing rutting and softening during regular rain events year-round and did not meet the requirements for the Primary Runway Condition performance measure. Air carriers cease operations at this airport when severe softness and rutting conditions occur.

Soft surface and rutting likely occurred because the embankment was constructed:

1. On low-quality subsurface material, as documented in comments in the Phase 2 as-builts (the material was replaced during Phase 2, but it is reasonable to assume that there are still low-quality materials within the embankment subsurface)
2. Using sandy surface course material, which is prone to raveling, especially because the fines content is diminished over time from wind and water

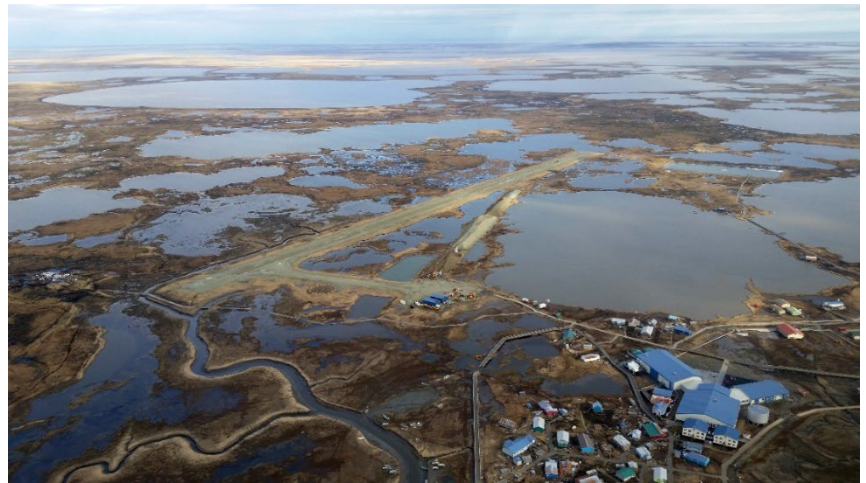
Organics were not left in place during construction, and there are no culverts within the embankment. The runway experiences soft surface conditions, bumps, and potholes. The air carriers cease operations when conditions are severe.

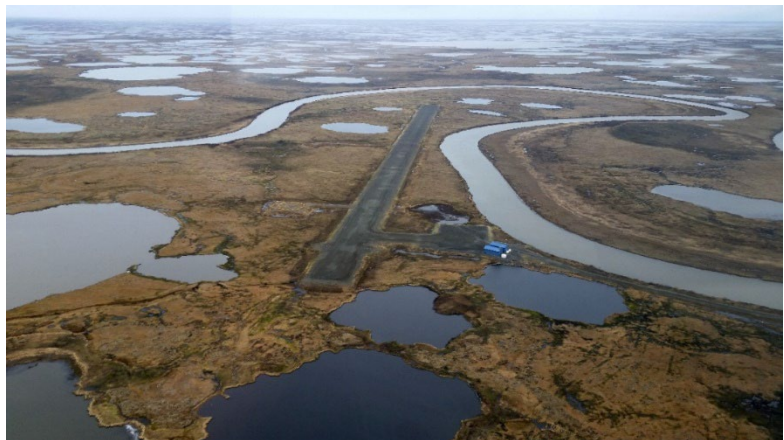
The embankment materials include a crushed aggregate surface course on top of 15 inches of high-quality crushed rock, which is on a material with a high fines content.

these improvements, the runway is in poor condition because of settlement-related damage and did not meet the requirements for the Primary Runway Condition performance measure. The runway has depressions, humps, cracking, and ponding, as well as shoulder erosion. The airport is included in the poor performance category for this study.

The pre-2007 runway was surrounded by water, indicative of a thaw bulb at the toe of the embankment, much like what is occurring again 15 years after the most recent construction project. The 2007 design appears to have anticipated differential settlement issues and attempted to mitigate them using an air convection embankment (ACE) in the thaw ponds at the toe, stabilizing geotextiles, and slope benching. The small area where riprap was placed on the shoulder appeared to be performing better than the rest of the embankment because no embanking cracking was observed at the expansion interfaces. The thermistors installed to monitor performance of the design were destroyed, and data ended up being inconclusive.

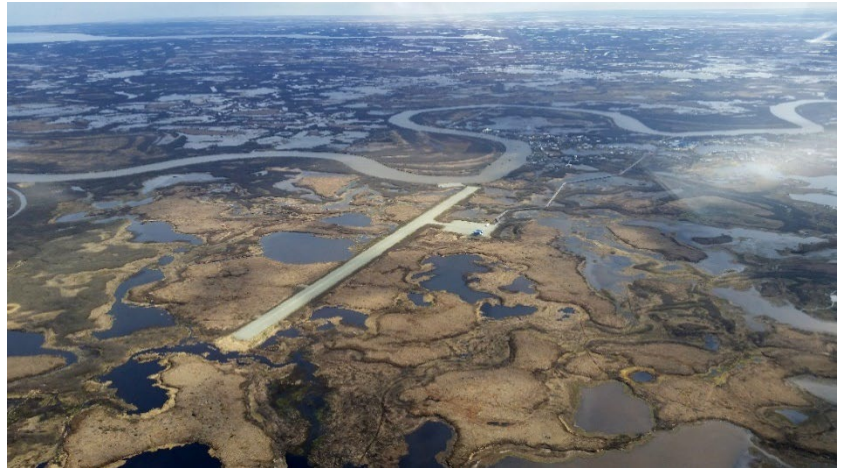
Tuntutuliak Airport (A61) has a gravel runway and is located along the Kinak River, with surrounding terrain that is characterized by numerous lakes, meandering streams, and marsh

underlain by shallow discontinuous permafrost. Native soils are saturated generally organic silt and silt with fine-grained sand underlain by variable thawed and compressible or warm thawed unstable ice-rich permafrost.

On-site materials (wet/frozen silt with organics) were used in construction of the embankment but imported sand and gravel was used for the airport surface. This airport was initially included in the good performance category for this study, but further analysis revealed numerous performance issues. The 2021 Capital Improvement and Maintenance Program (CIMP) inspection report did not identify any major failures but did note that there was not a good balance of fines in the runway and dust palliative was not being used. The 2022 APEB nomination form states that the runway safety area has experienced sinking and cracking.

The airport was relocated in 2010. No significant runway deterioration has occurred since relocation. The airport does face erosion threats from the adjacent Kinak River, and the RSA needs to be widened to align with a change in its critical aircraft designation.

- ▶ Significant settlement has occurred along the sides of the runway. Some areas of the light line are estimated to be up to 1.5 to 2 feet lower than the centerline. Beyond the light line, the shoulder and safety area have subsided even more, making the cross slope substantially out of design specifications. The subsidence appears to be relatively uniform.
- ▶ Soft shoulders and longitudinal cracks were observed; these failures were visually obscured by vegetation.
- ▶ The profile was fairly smooth, with no substantial longitudinal settlement.
- ▶ Significant vegetation along the edges of the runway was observed, obscuring some of the edge lights, as shown in Figure 15.

One of the models in the 2006 thermal analysis indicated that, by 2020, the embankment could be above 32°F at depths of 8 to 10 feet. The observed settlement could be caused by this thawing penetrating through the embankment to the original ground, meaning the thawing trend will continue. Borings into the original ground revealed ice-rich soils of varying ice content, indicating that further thawing will not be uniform.

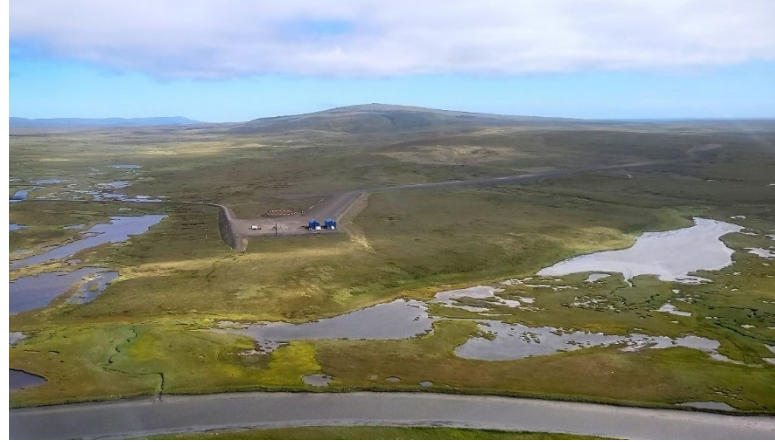
Tununak Airport (4KA) has a gravel runway and is located inland near Tununak Bay. The surrounding terrain is a wide flat river floodplain bordered by gentle to moderate

slopes below a flat-topped mountain. Native soils include fine-grained soils, predominantly silt with a wide range of organic content, overlaying coarse-grained soils (sand and gravel with fines), above sedimentary bedrock (siltstone and claystone).

The runway was relocated inland from the coastal shore with construction completed in 2015. The runway is still experiencing settlement and grading issues. It has been reported that the airport was built on an ice lens, and thaw has caused a sink hole that must be filled every spring. Settlement and drainage issues are extensive; soft spots, ponding, and dips in the runway have been so severe that they have caused runway closures.

Review of the 2015 as-builts shows a mix of cut and fill to traverse the terrain, which resulted in variable embankment thickness, ranging from approximately 9 feet to 22 feet. Further, the geotechnical recommendations indicated an 8-foot embankment depth was expected to protect from permafrost thaw. However, it is reported that thawing of subgrade permafrost and ice lenses have been observed as recently as 2020. This thawing is likely occurring at a differential rate because of the varying embankment thickness and thaw depths.

Further, the reported ice lens was not identified in the test holes, nor was it noted on the as-builts. People familiar with the construction of the airport reported that winter construction occurred, which included placing chunky frozen material over frozen ground. In some cases, material was placed over ice-filled ponds, which may be the reported ice lenses.

- ▶ Significant settlement of the embankment was observed extending beyond the runway operational area. Attempts to fill some of the settlement areas were evident, though these attempts did not make a significant difference in surface conditions. Material was evidently taken from the safety areas to fill dips within the runway operational area.

- ▶ Water ponding at the toe was evident, mostly on the uphill side. Tununak’s (4KA) design called for ditches with rock lining to direct runoff to the culvert under the runway. The ponding may be the result of the ditch slopes failing or the ditching not providing positive drainage because of the thawing of ice-rich soils.

- ▶ Longitudinal cracks were noticed along the runway shoulder.
- ▶ Gravel berms, 8 to 10 inches high, were observed. They appeared to be left by grading operations and serving no apparent purpose.

- ▶ Lighting system issues caused by settlement were observed.
- ▶ Culverts were found to be relatively straight. Straight culverts are good because the embankment is very thick at the culvert locations, which would make replacement difficult.

The embankment failures and settlement are believed to be the result of the use of winter construction practices and inadequate settlement periods. Over-excavating the ice-rich subgrade soils may have yielded better results than trying to keep the subgrade frozen. Additionally, the design should have included more detail to ensure positive draining and avoid ponding at the toe of the embankment.
